Study on the Issues about Hydrogen Explosion at Fukushima Dai-ichi NPS

**Nuclear Energy System Safety Division
Japan Nuclear Energy Safety Organization**

**Technical Workshop on the Accident of TEPCO's
Fukushima Dai-ichi NPS**

July 2012

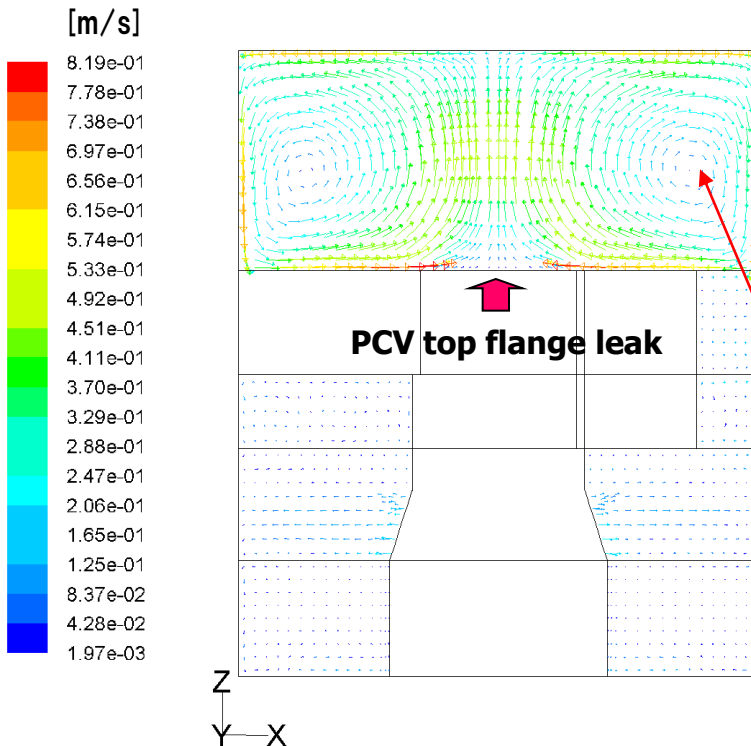
Hydrogen gas flow velocity

Hydrogen gas of 400kg released to the top floor (5F) of R/B from the PCV top flange

Released flow rate of hydrogen gas was 100kg/h for 4 hours

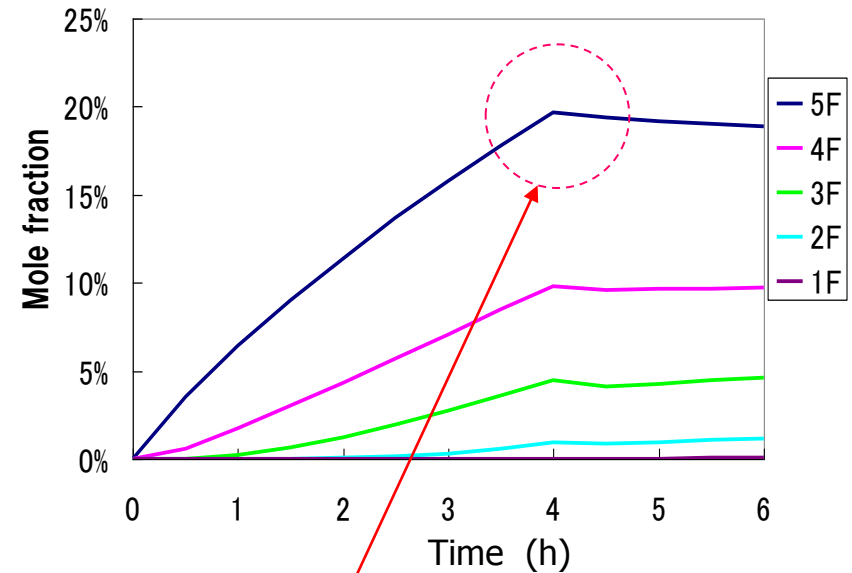
Hydrogen gas conc.

Released hydrogen gas accumulated evenly in the top floor (5F) with high concentration of about 20vol%

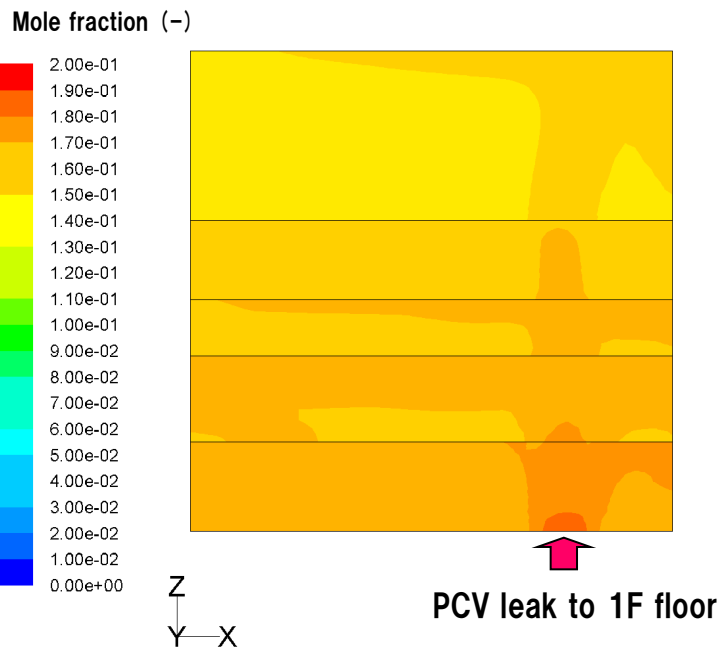
Hydrogen gas distribution

Hydrogen gas of 1000kg released to the first floor (1F) of R/B from PCV penetration, S/C or etc.

Released flow rate of hydrogen gas was 200kg/h for 5 hours

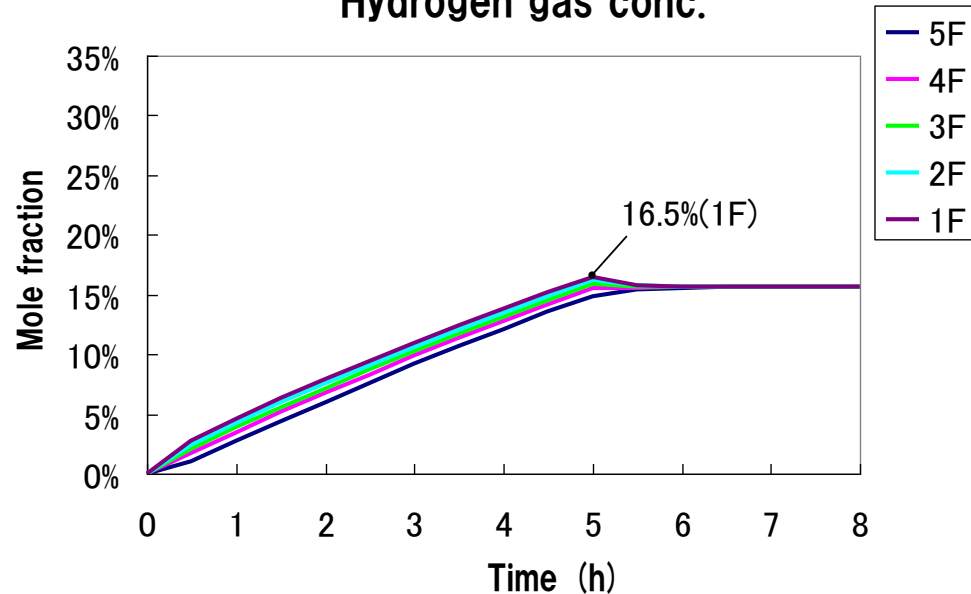
Hydrogen gas conc.

Released hydrogen gas accumulated evenly in the whole of R/B with high concentration of 16–17vol%

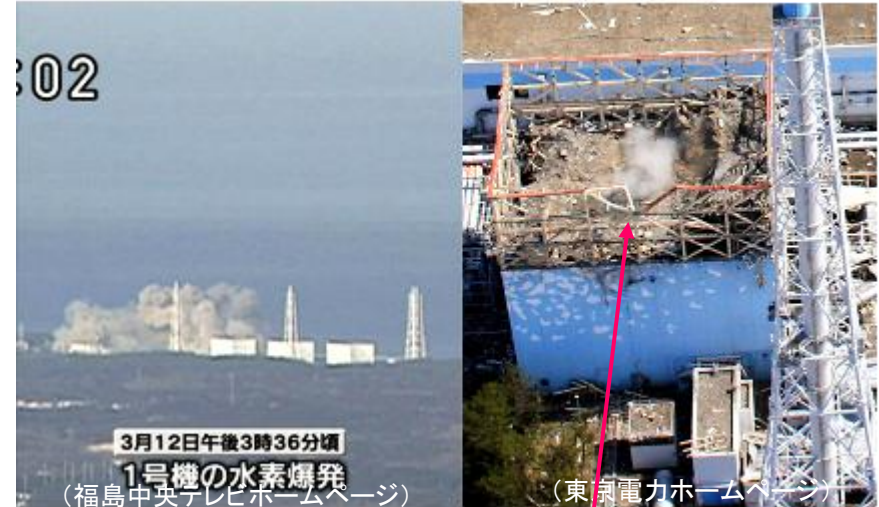
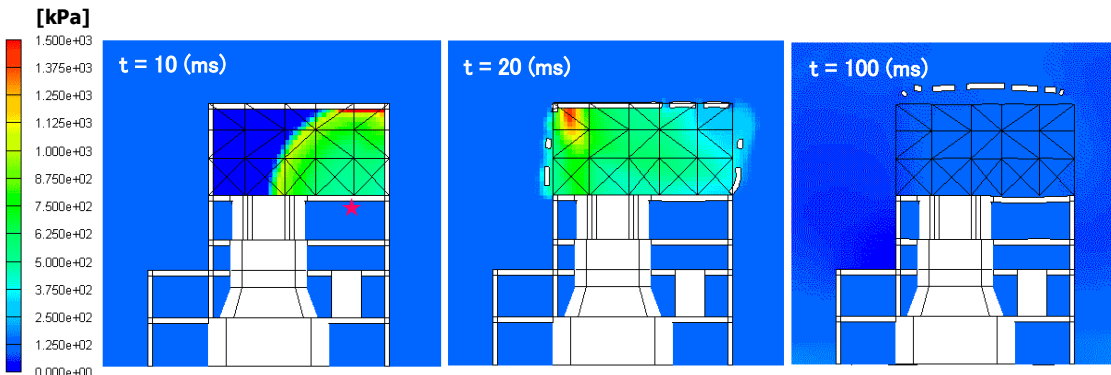
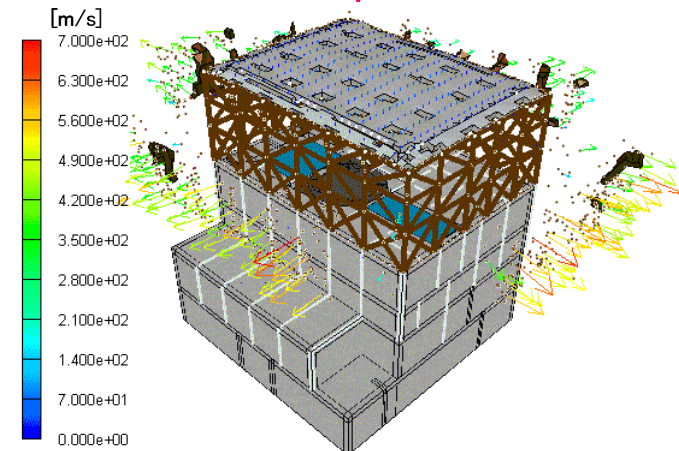
Propagation of detonation pressure in the reactor building of Unit 1

Walls and roofs of top floor (5F) were largely destroyed and debris scattered around the R/B

Good simulation of the actual explosion at Unit 1

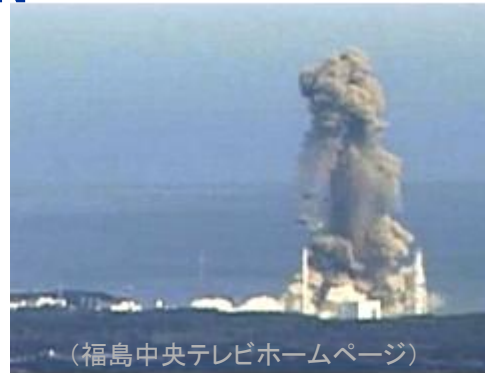
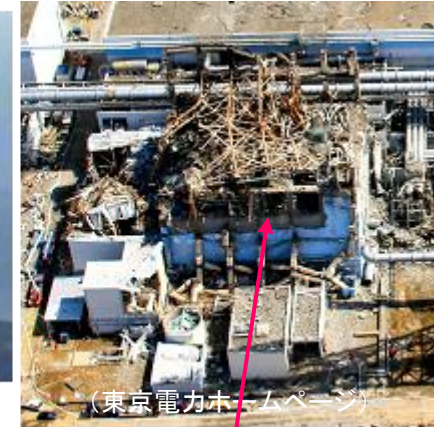
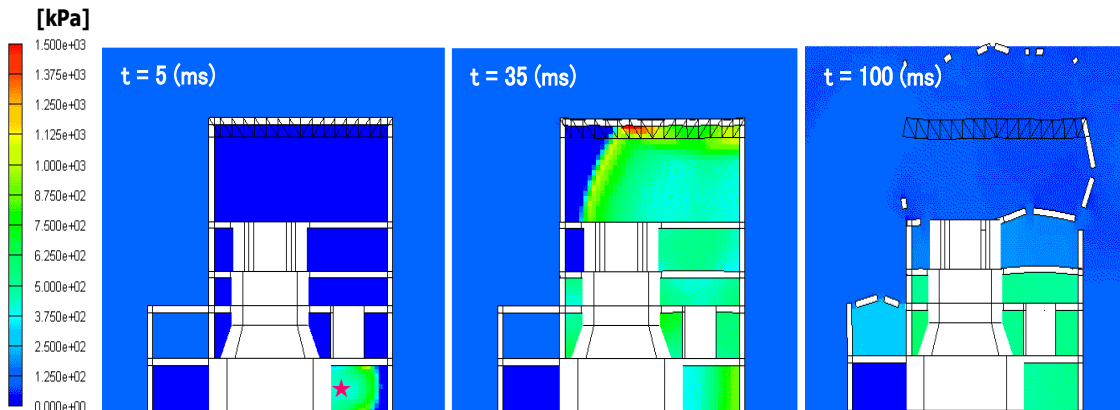
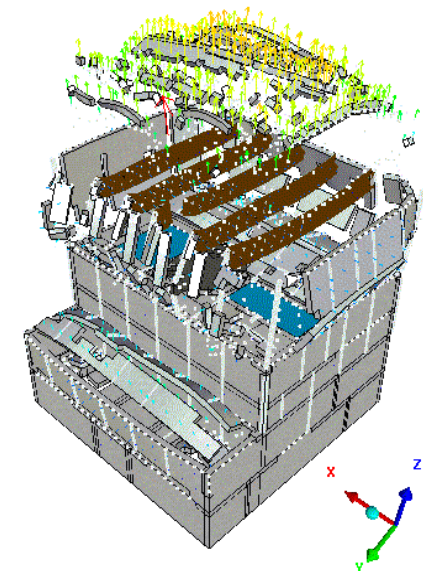
Propagation of detonation pressure in the reactor building of Unit 3

Walls and roofs of top floor (5F) and 4F were largely destroyed and debris scattered around the R/B

Good simulation of the actual explosion at Unit 3

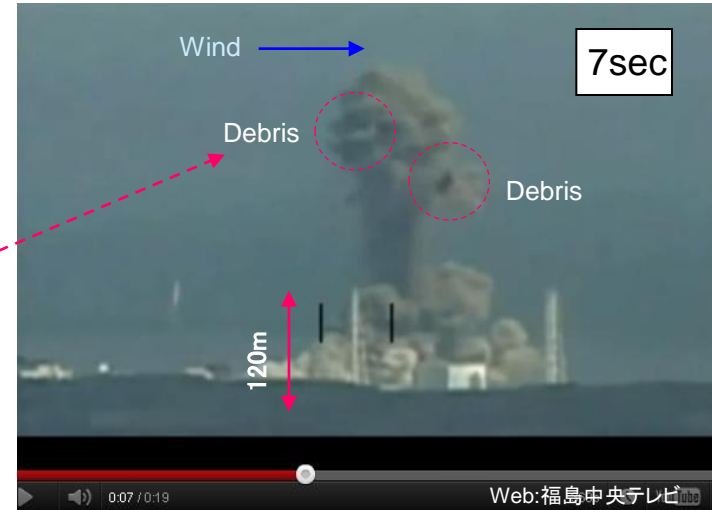
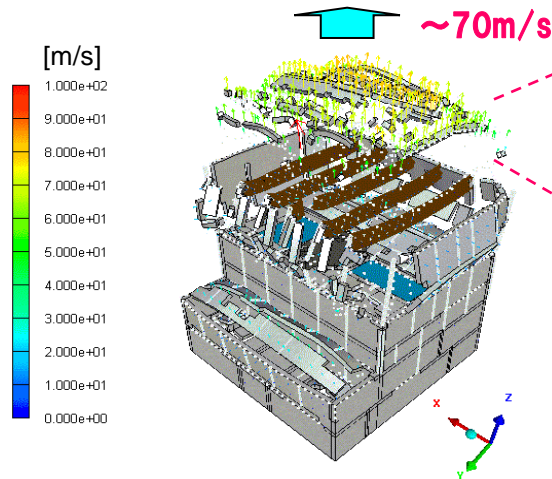
TV broadcast picture

- Debris with initial velocity of 70m/s can reach to about 250m height from the top of R/B in 7 seconds.
- Agreed with the actual phenomena observed at the Unit 3.

Debris with initial velocity of 20 m/s to 70 m/s

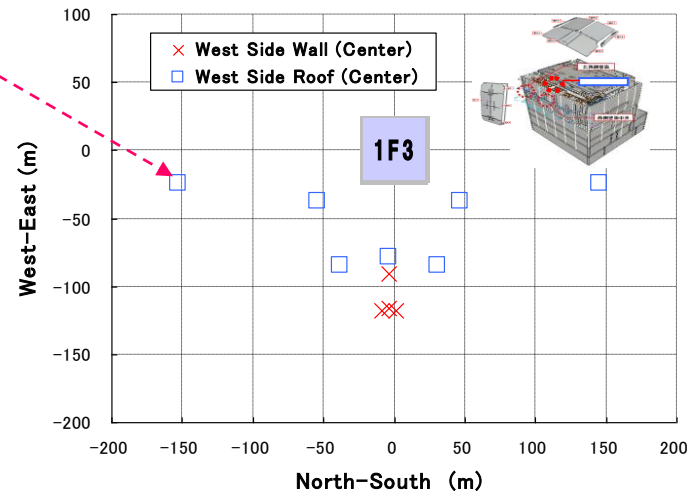
Scattered debris on the ground around Unit 3

- Distribution of scattered debris of walls and roofs of the west side of Unit 3 agreed with the actual distribution.

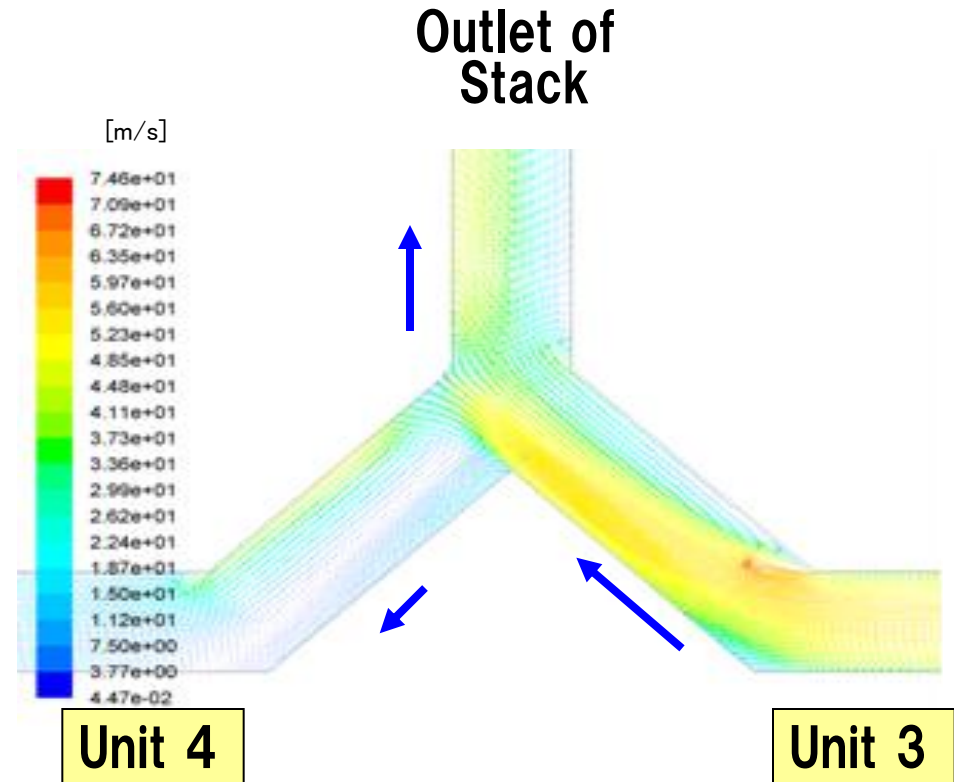
CFD analysis results

Reverse gas flow in to the R/B of Unit 4

- All of vented gas from Unit 3 releases to the environment through the stack with low venting flow rate.
- Around one quarter of the vented gas from Unit 3 reversely flows into the R/B of Unit 4 with high venting flow rate of 20kg/s.

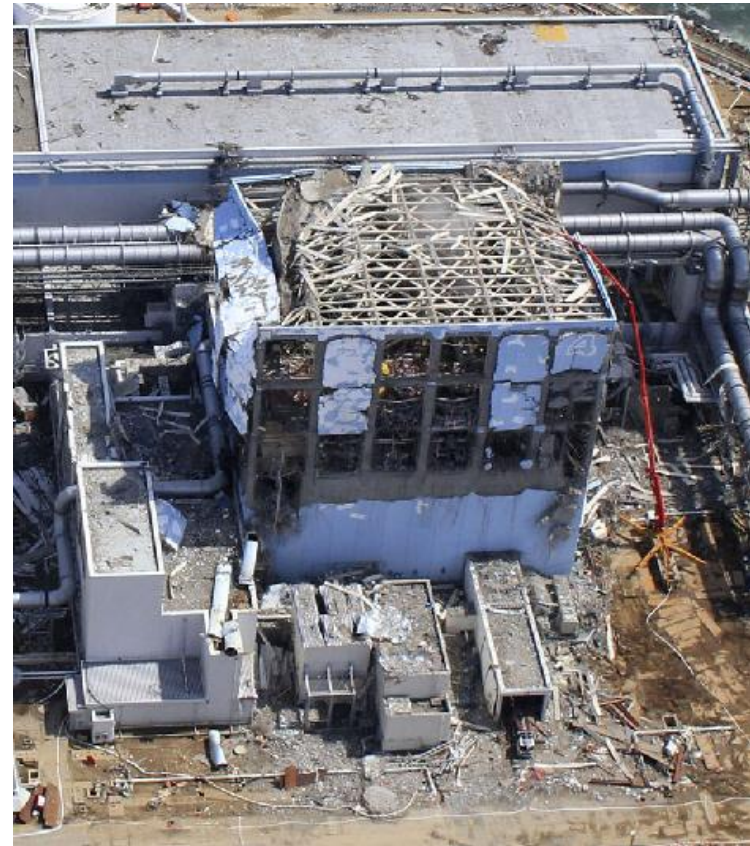
- Condition of the exploded R/B of Unit 4 was between that of Unit 1 and Unit 3.
 - Indicating the order of total amount of hydrogen gas exploded in the R/B of Unit 4 was between Unit 1 (400kg) and Unit 3 (1,000kg).
 - Reported that the water level of the spent fuel pool kept covering the top of fuels at Unit 4 .
 - Supposed small amount of hydrogen gas generation by radiolysis in a few days before the explosion
- Indicating the vented gas from Unit 3 reversely flowed into the R/B of Unit 4

- **Hydrogen gas generation in SFP of Unit 4:
Small amount of hydrogen gas generation in the pool.**
 - **Reverse flow of vented gas from Unit 3 to Unit 4:
How did large amount of hydrogen gas flow into the
R/B of Unit 4 from Unit 3?**
- Need of inspection of the junction area of vent lines of Unit 3 and Unit 4 (bottom of stuck) to evaluate the flow distribution at the junction area with radiation monitor or any other ways**
